# Manhole Inspection Summary

Manhole # S23M\_\_018MH

Insp Date: **6/18/08 10:32 AM**

**Location** Address: **1617 Cole St**

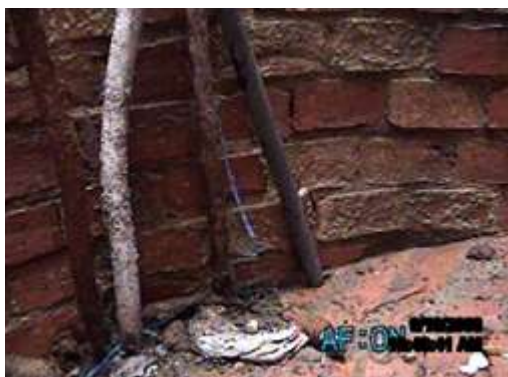
Misc

Condition: ☐ Sound ☐ Cracked ☐ Root Intrusion ☐ Deteriorated ☐ Leaks ☒ **Debris**

debris on bench

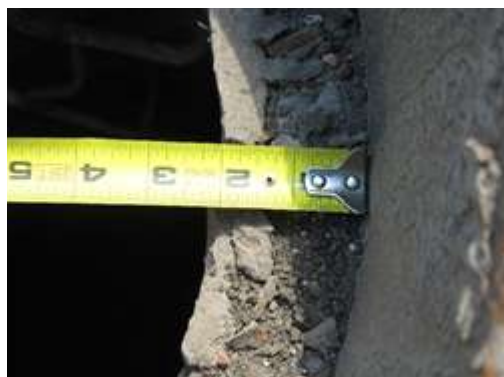
Defect 1

Offset: **2** (in.)

frame offset 2 inches

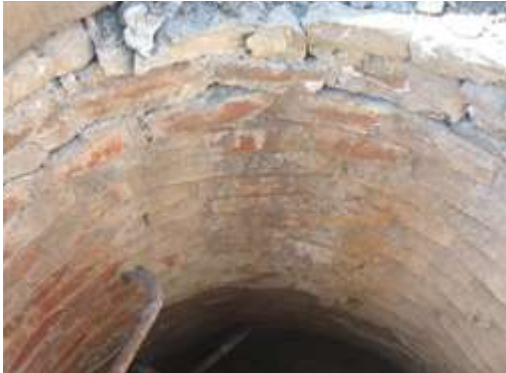
Defect 5

Condition: ☐ Sound ☐ Cracked ☐ Root Intrusion ☒ **Loose Brick** ☒ **Deteriorated**

chimney deteriorated

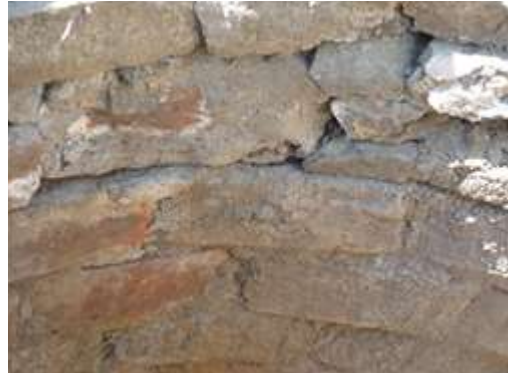
Defect 6

chimney loose bricks

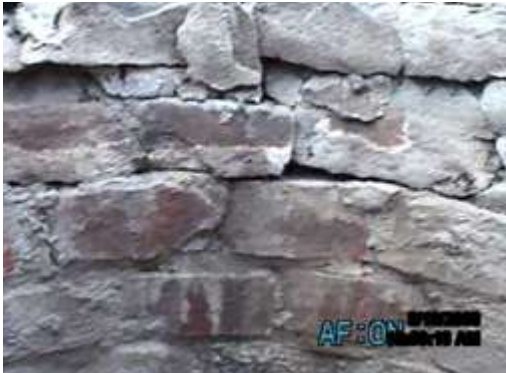
Defect 4

Infiltration: ☐ None ☐ Joint ☐ Cracks ☒ **Mortar** ☐ Roots ☒ **Wall**

chimney infiltration at mortar and wall

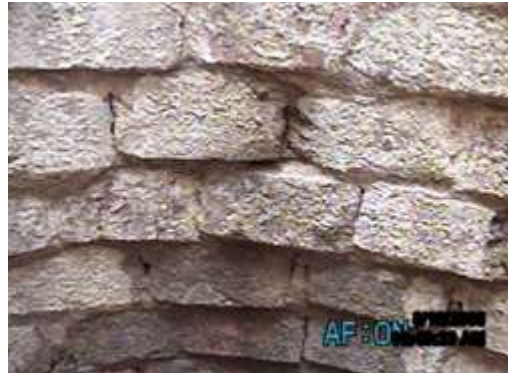
Defect 3

Condition: ☐ Sound ☒ **Cracked** ☐ Root Intrusion ☒ **Loose Brick** ☐ Deteriorated

Infiltration: ☐ None ☐ Joint ☒ **Cracks** ☒ **Mortar** ☐ Roots ☒ **Wall**

corbel cracked and loose bricks,  
infiltration at cracks and mortar

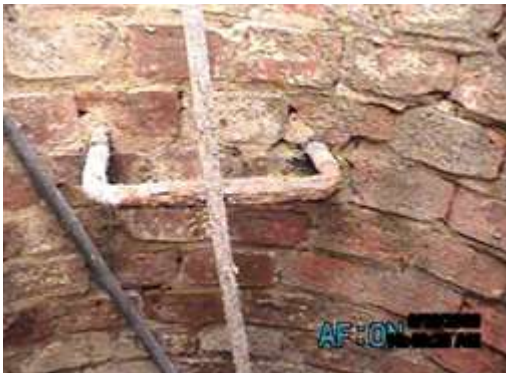
Defect 2

Count: **6** Missing: **0** ☒ **Corroded**

steps corroded
